## Introduction

This document provides background information and troubleshooting steps that should help to resolve most ethernet communication problems with the MP150. The associated flow chart is designed to help identify the specific factor preventing communication.

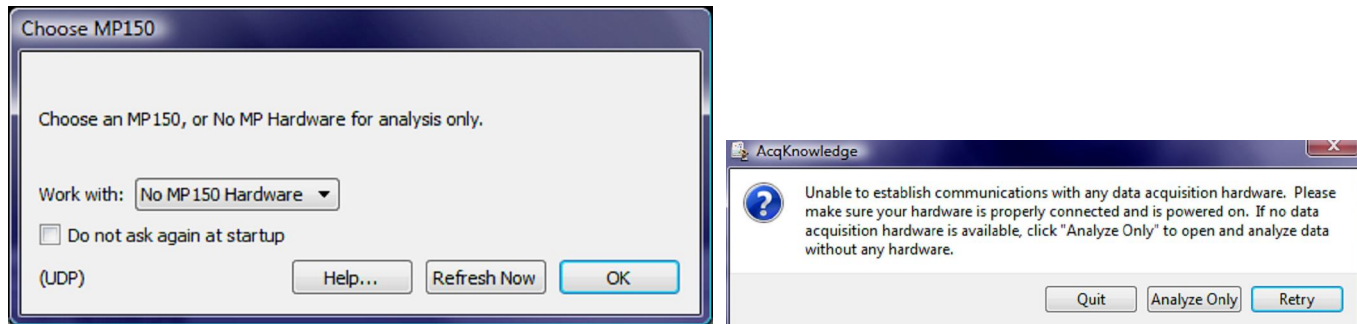
MP150 communication can be compromised by a variety of factors. Typically, the symptom will be the presentation of a dialog box such as these below during software startup:

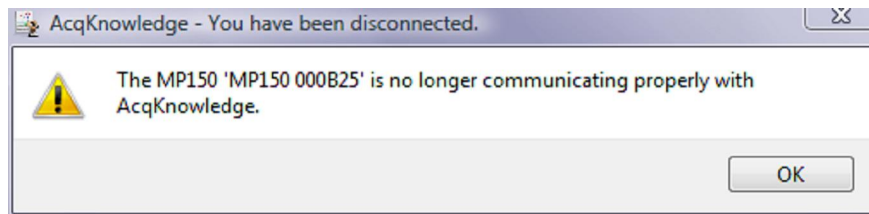
If communication is lost after it has been established, a message such as this may appear:

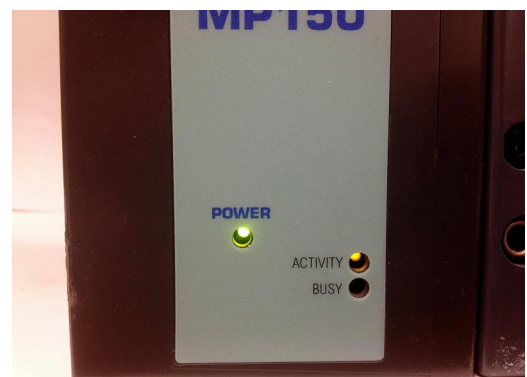
The MP150 must be functional, properly powered, and connected with the correct type of cable. On the front of the device there are three status lights labeled **POWER**, **ACTIVITY**, and **BUSY**. When the device is on, the power light should be a steady green. A flashing **POWER** light indicates a problem with the device or its power supply. The power supply should provide 12 volts and at least 1.25 amps (newer units have a supply rated at 4.17 amps). As indicated on the back of the MP150, the tip of the supply connector should be positive. BIOPAC cannot guarantee the operation of the MP150 if it is driven by a power supply not provided by us specifically for use with an MP150. If there is any doubt as to whether the correct supply is being used, the supply should be disconnected until it has been determined said supply is one with which the MP150 was designed to operate. If the power supply is appropriate for an MP150, make certain that the cable connecting the supply to the MP150 is fully inserted. Verify also that the power cord is fully plugged into a functioning electrical supply outlet.

*MP150 Status Lights*

If the power light is on steady and green as it should be, next check the other two status lights. When the unit is turned on, the Activity and Busy lights should both turn on for a brief period, then the Busy light should turn off and stay off. The Activity light should flash intermittently. On older models, Activity and Busy lights may flash alternately to indicate that the device does not detect a network connection. On more recent models, this state is indicated by a double-flashing of the Activity light. In this state, the Activity light flashes twice, pauses for a couple of seconds and repeats indefinitely.

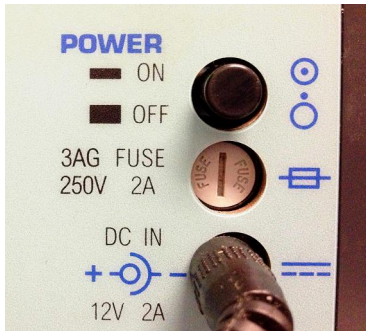
If the power light is not activated by the power switch and the power supply and connections have been verified, the next step is to check the fuse. Beneath the power switch on the back of the MP150 is a gray fuse holder (see photos below). With a small slotted screwdriver, push in on the fuse holder and turn counter-clockwise one quarter of a rotation. This will disengage the fuse holder causing a spring to push it part way out. Pull the fuse holder the rest of the way out and then remove the fuse. There is a fine wire running down the center of the fuse. If that wire is visibly broken, or if an ohmmeter connected to the two end caps of the fuse indicates a high (typically  $>100\Omega$ ) resistance, then the fuse should be replaced.

*Location of fuse holder; Back of MP150*

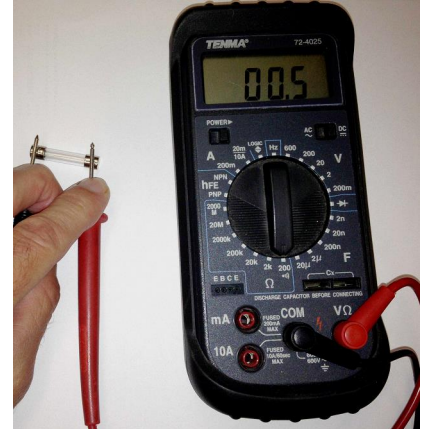
*Testing fuse with digital multimeter*

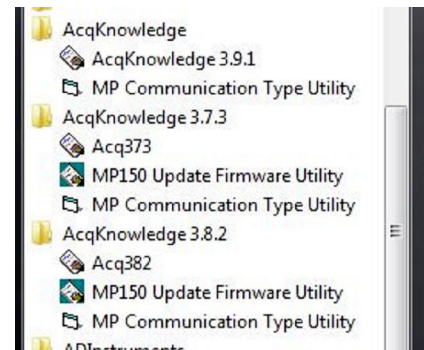
If you are using one of these older versions of AcqKnowledge on a computer running Windows XP, the Windows %Start+menu should allow you to find a utility program that configures the communication type that the software will try to use. Click the %Start+menu in the Windows Task bar, click %All Programs+to expand the list, and then look for an %AcqKnowledge+entry that includes the %MP Communication Type Utility+(the system used to generate the image at right has multiple AcqKnowledge versions installed. You should expect to find only one on your system).

*MP150 Communication Type Utility*

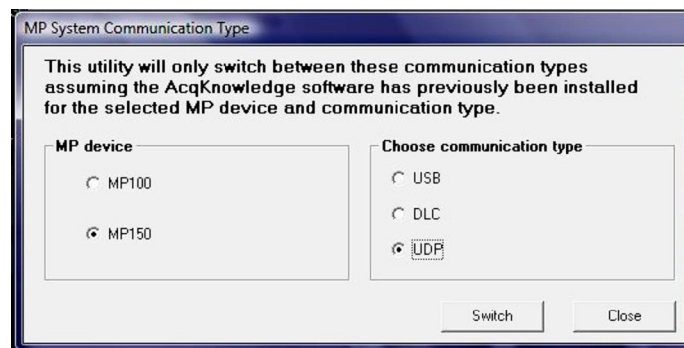
The MP Communication Type Utility presents a single dialog box that allows you to specify the type of MP device you are using and the communication protocol if the device is an MP150 (see image below). If the utility has %MP100+selected, click the %MP150+radio button. Try first with the %UDP+radio button selected. If you made any changes, click the %Switch+pushbutton, cycle the power on the MP150 (turn it off and turn it on again), and re-start AcqKnowledge. If the device does not communicate with UDP protocol specified by the communication type utility, try selecting DLC protocol (if you are using Windows XP or earlier), cycling the power on the MP150, and re-start AcqKnowledge again.

*MP150 Communication Type Utility Dialog Box*

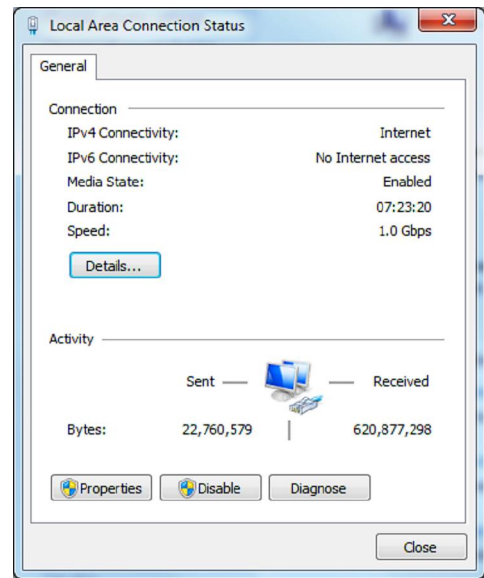
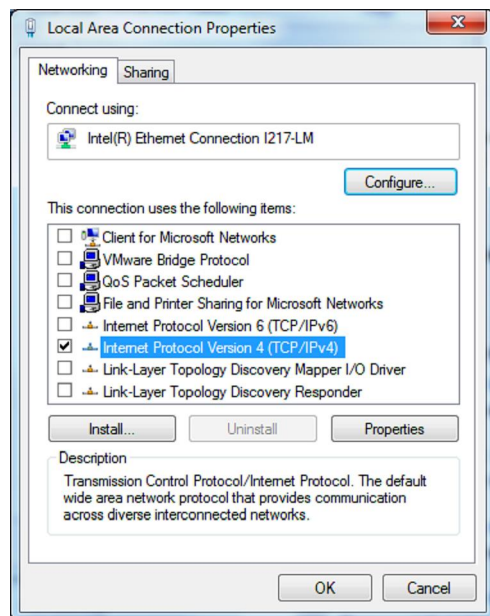
1. Open the %Network and Sharing Center+control panel and select the %Local Area Network+to which the MP150 is connected. This will produce a Local Area Connection Status dialog resembling the figure on the right.
2. Click the %Properties+pushbutton. It may be helpful to turn off all services aside from TCP/IP version 4 as shown below.
3. With %Internet Protocol Version 4 (TCP/IPv4)+selected, click the %Properties+button for the Local Area Connection Properties dialog box. The Properties for this protocol may be set for the use of a static IP address (see figure below right). The IP address to use is 169.254.111.111 with a Subnet mask of 255.255.0.0.

*Local Area Connection Properties*

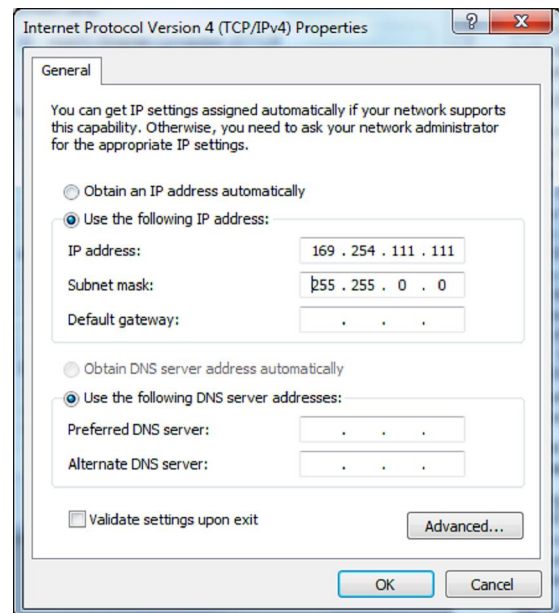
*TCP/IP Version 4 Properties*

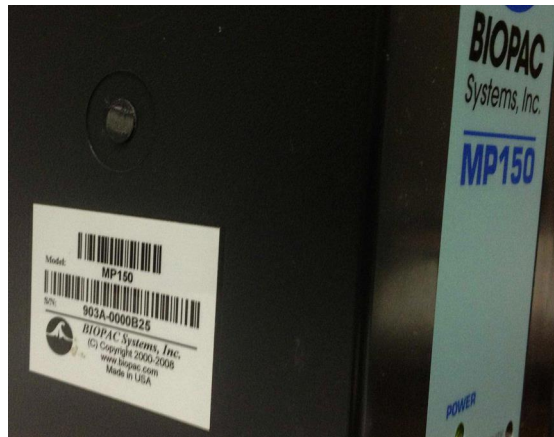
*MP150 Serial Number*

The administrators of the network can help with problems of the first two types. Provide them with the MAC address of the MP150. The first six digits of the MAC address of an MP150 are always 00 90 3D. The last six digits are the same as the last six digits of the device's serial number. The serial number is printed on a sticker on the MP150's left side. If MP150 communication can be established (e.g., with all other network cards disabled), the MAC address can also be determined from within *AcqKnowledge*. In recent versions of *AcqKnowledge*, choose **MP150 > MP150 Info...** to find the MAC address. If the MAC address is provided to network administrators, they should be instructed to make sure that the device is not blocked and that it is assigned an IP address that is in the same subnet as the ethernet card to which it is attached.

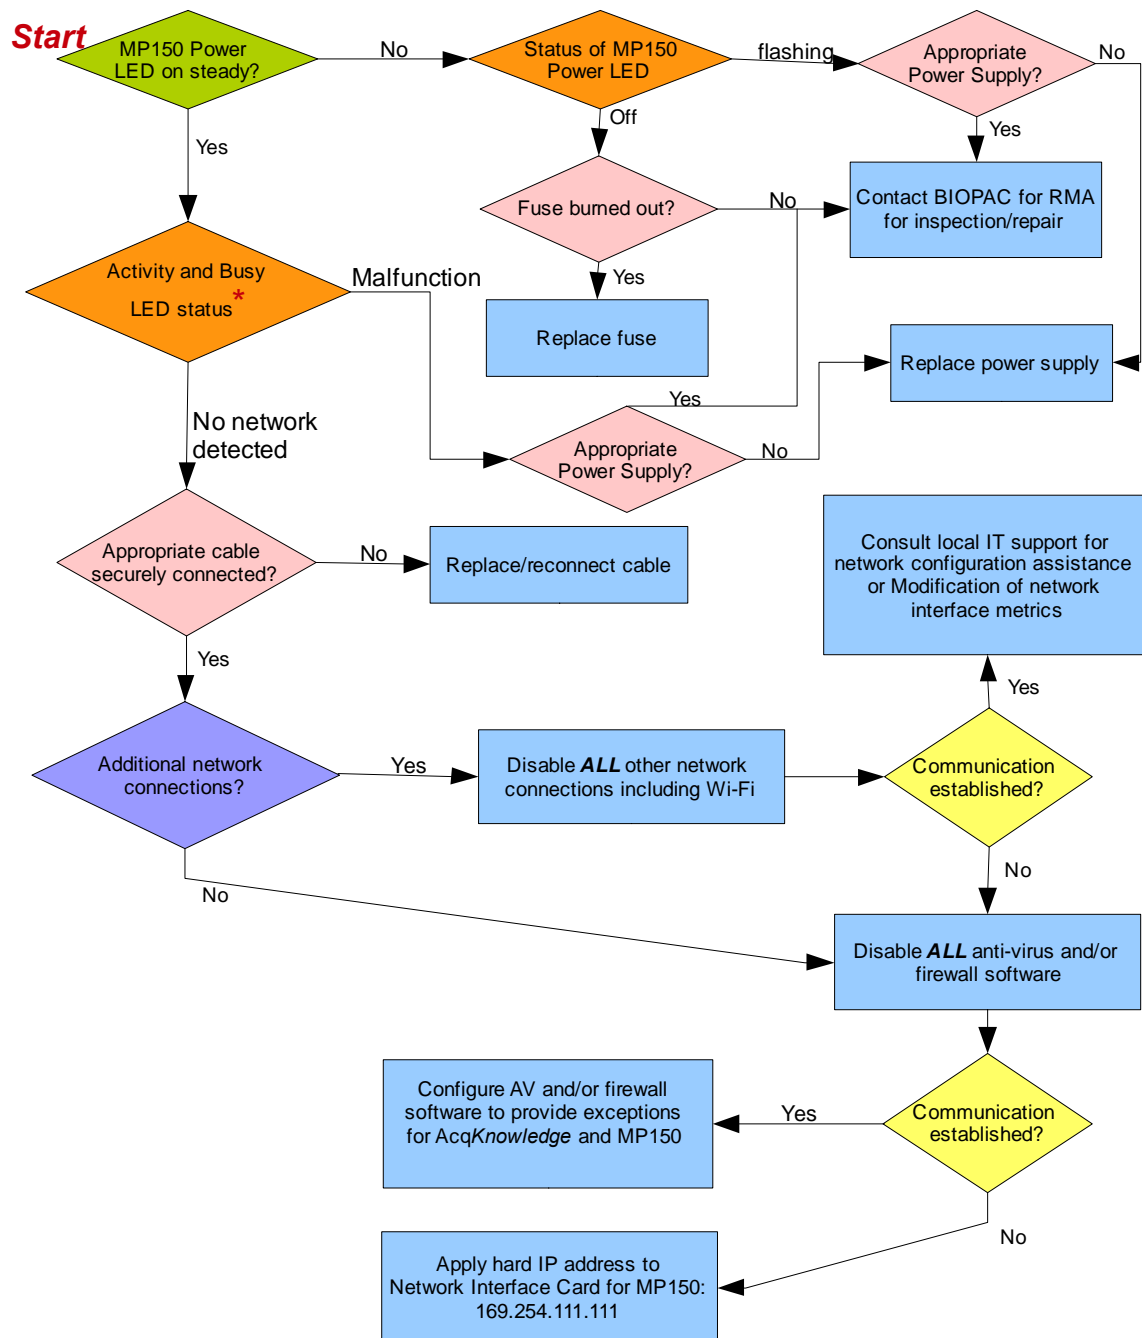
\* See MP Systems Hardware Guide available via the %Help+menu in *AcqKnowledge*. The guide contains a table describing the meaning of different LED patterns for the Activity and Busy LEDs. Under normal operation when not acquiring data, Busy LED is off, and Activity LED flashes (amber) at irregular intervals. If Activity LED double flashes at regular intervals (newer MP150s) or if Activity and Busy LEDs flash alternately (older MP150s), then MP150 does not detect that it is connected to a network.
